TECHNICAL NOTE

Bureau of Land Management U.S. DEPARTMENT OF THE INTERIOR

GOLD CREEK FISH PASSAGE STRUCTURE

John W. Anderson, Fishery Biologist
Coos Bay District, Oregon

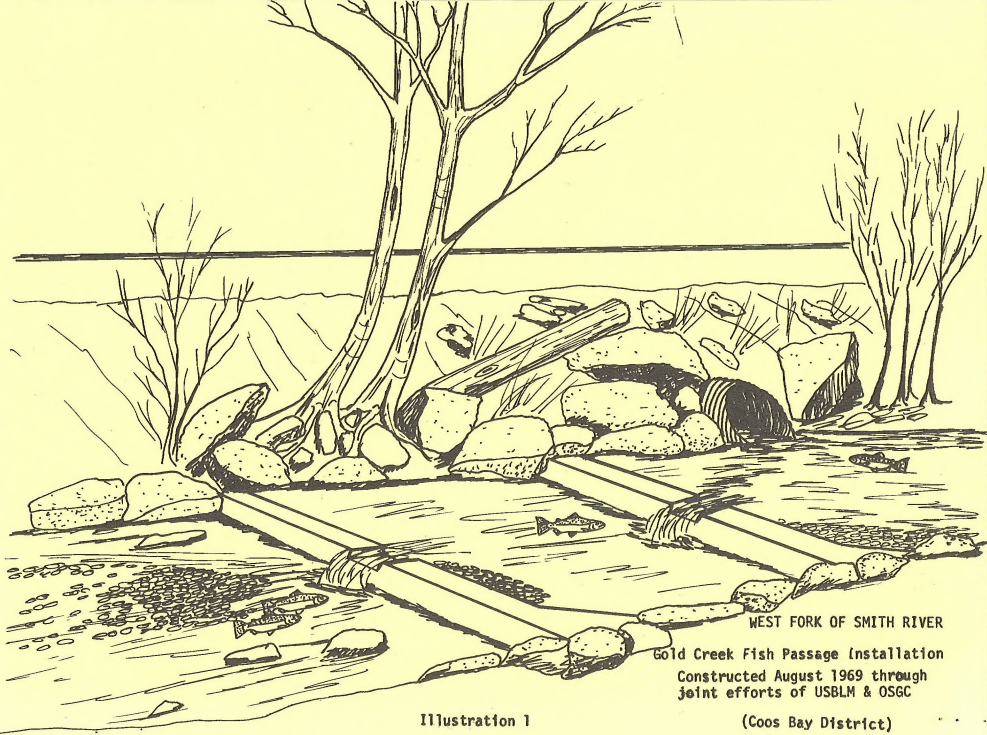
Illustration 1

The North Area Manager and District Engineer, Coos Bay District, and Oregon Game Commission employees suggested that concrete sills be installed in the river a few yards downstream from the culvert (Illustration 1). The water level of the West Fork would then be raised to the height of the culvert making it permanently passable by upstream migrating fish. The Bureau of Land Management and the Oregon State Game Commission cooperated in constructing such a facility in the summer of 1969 at a total cost of \$2,058.

Steelhead trout have been observed during the winter of 1970 using the pools created by the two dams as resting areas -- (Illustrations 1 and 2). A bar of spawning gravel developed on a former bedrock area below the lower dam and was used by steelhead trout for spawning. The new spawning area was created by the construction of the dams.

Gold Creek Fish Passage Installation
Constructed August 1969 through
joint efforts of USBLM & OSGC

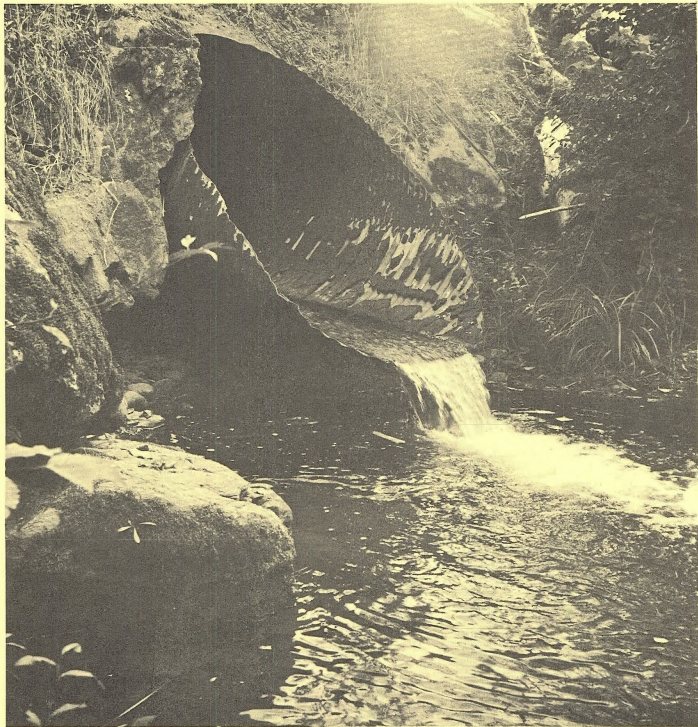
A culvert installation on Gold Creek, a tributary of the West Fork of Smith River, was identified as a fish passage problem. The culvert was improperly placed when the West Fork of Smith River Access Road was constructed. The road is a mainline, hard surface road paralleling the West Fork Smith River and crossing the mouth of Gold Creek. It was estimated that it would cost \$10,000 to remove and lower the culvert to an acceptable level for upstream fish passage.

Illustration 3 - GOLD CREEK - Culvert outlet before dams were built.
Overhang prevented passage of salmon and steelhead.

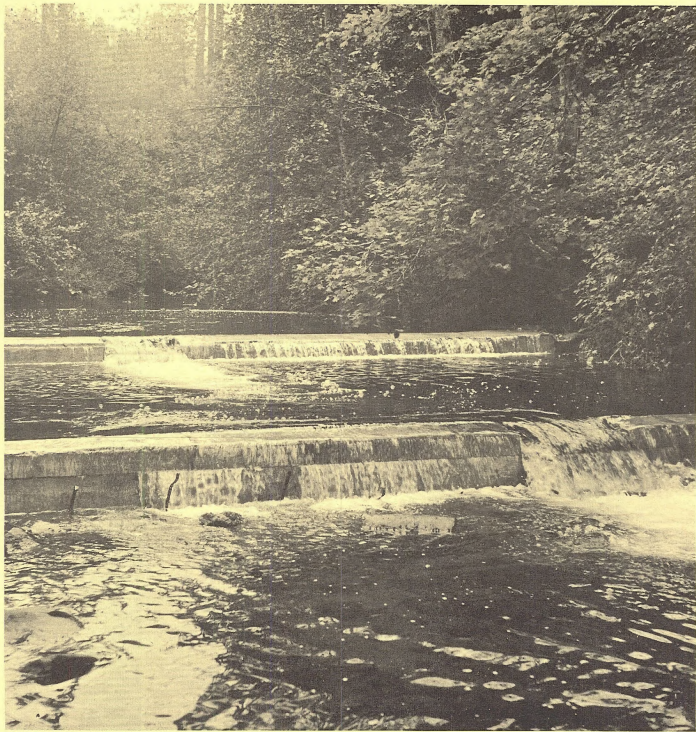
Illustration 4 - View of West Branch of Smith River after dams were completed. Form iron was removed after photograph was taken.

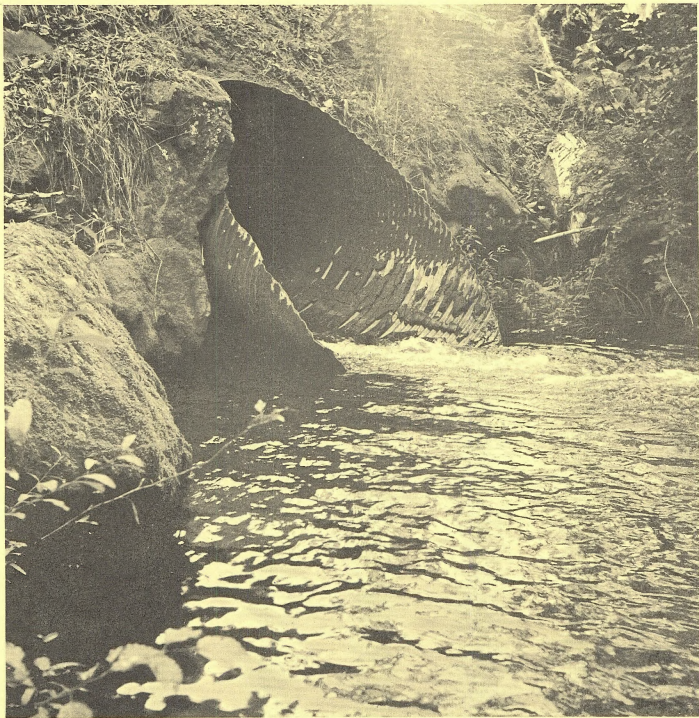
Illustration 5 - GOLD CREEK - Culvert outlet after dams were built.
